# IUEC INCIDENT SUMMARY

CLOSE CALLS, NEAR MISSES AND INJURIES

“NEAR MISS”

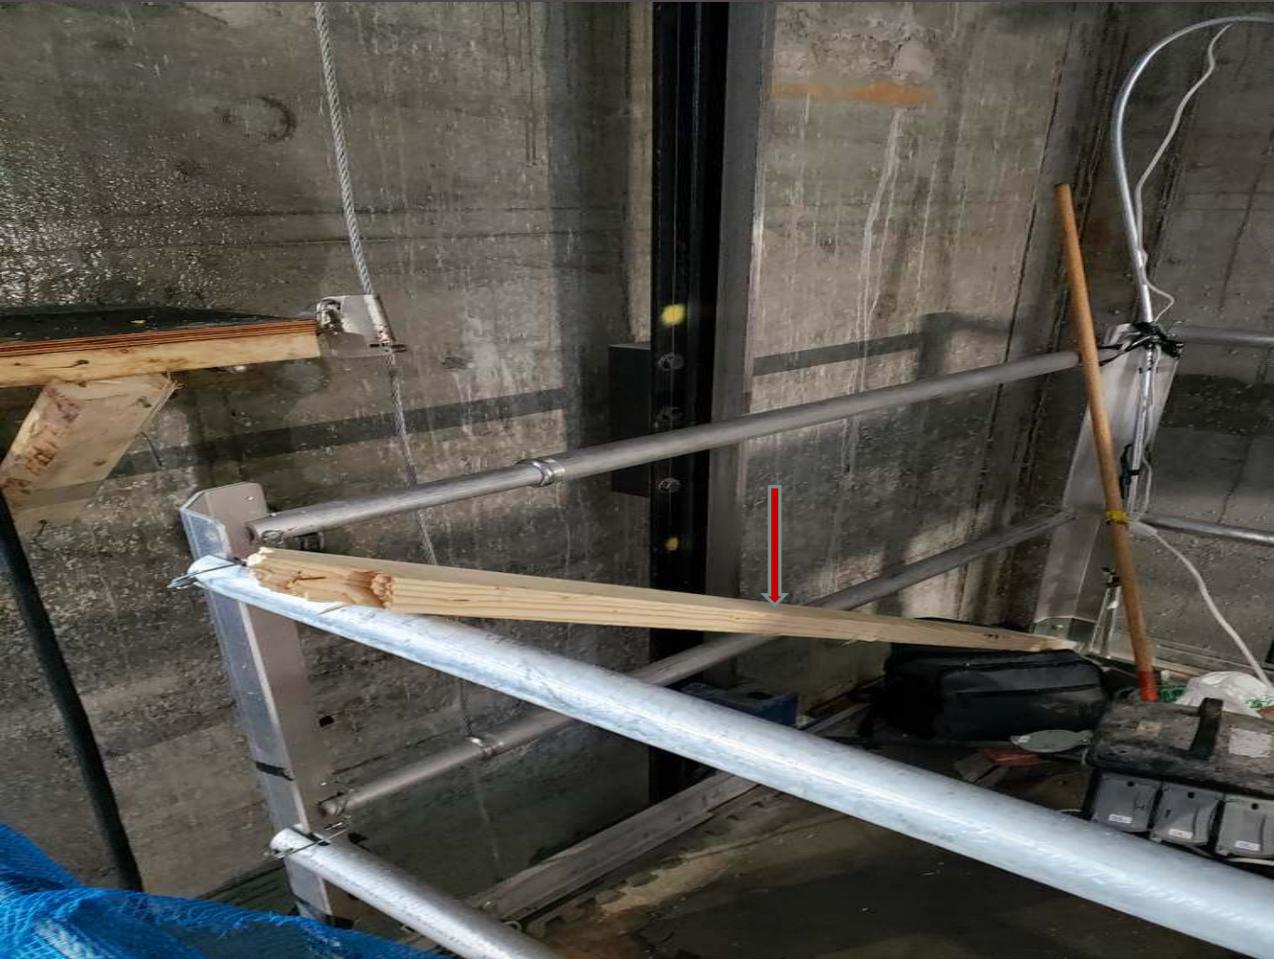
- A mechanic and apprentice were working from a go-devil/false car on a new construction job. They had just stepped off the platform on the 7<sup>th</sup> floor to grab material.
- At that instant ice debris came down the hoistway from the 22<sup>nd</sup> floor. The ice hit the crash deck that was made of 2x4's and ¾" plywood with metal mesh grating.
- The ice landed on top of the crash deck and broke thru knocking the 2x4's down the hoist way striking the go-devil.
- The crew was fortunate that that they were off the go-devil and not injured.

- Always follow the company Safety Policy.
- Always perform a JHA/JSA per company policy.
- Visually check the crash deck daily.
- Always check the surrounding areas of open hoist ways for debris, ice and or snow that if dislodged can come down the hoist way.
- Employer Responsibilities

- Overhead protective covering of 2-inch planking, 3/4-inch plywood, or other solid material of equivalent strength, shall be provided on top of every material hoist cage or platform.

- OSHA does not set forth specific performance requirements in the scaffolding standard for falling object protection systems. However, in order to fulfill the requirements of the standard - that is, to abate the struck-by hazard presented by potential falling objects, the falling object protection systems would need to be sufficiently strong to withstand the potential impact of the objects above the scaffold.
