# IUEC INCIDENT SUMMARY

CLOSE CALLS, NEAR MISSES AND INJURIES

“NEAR MISS”

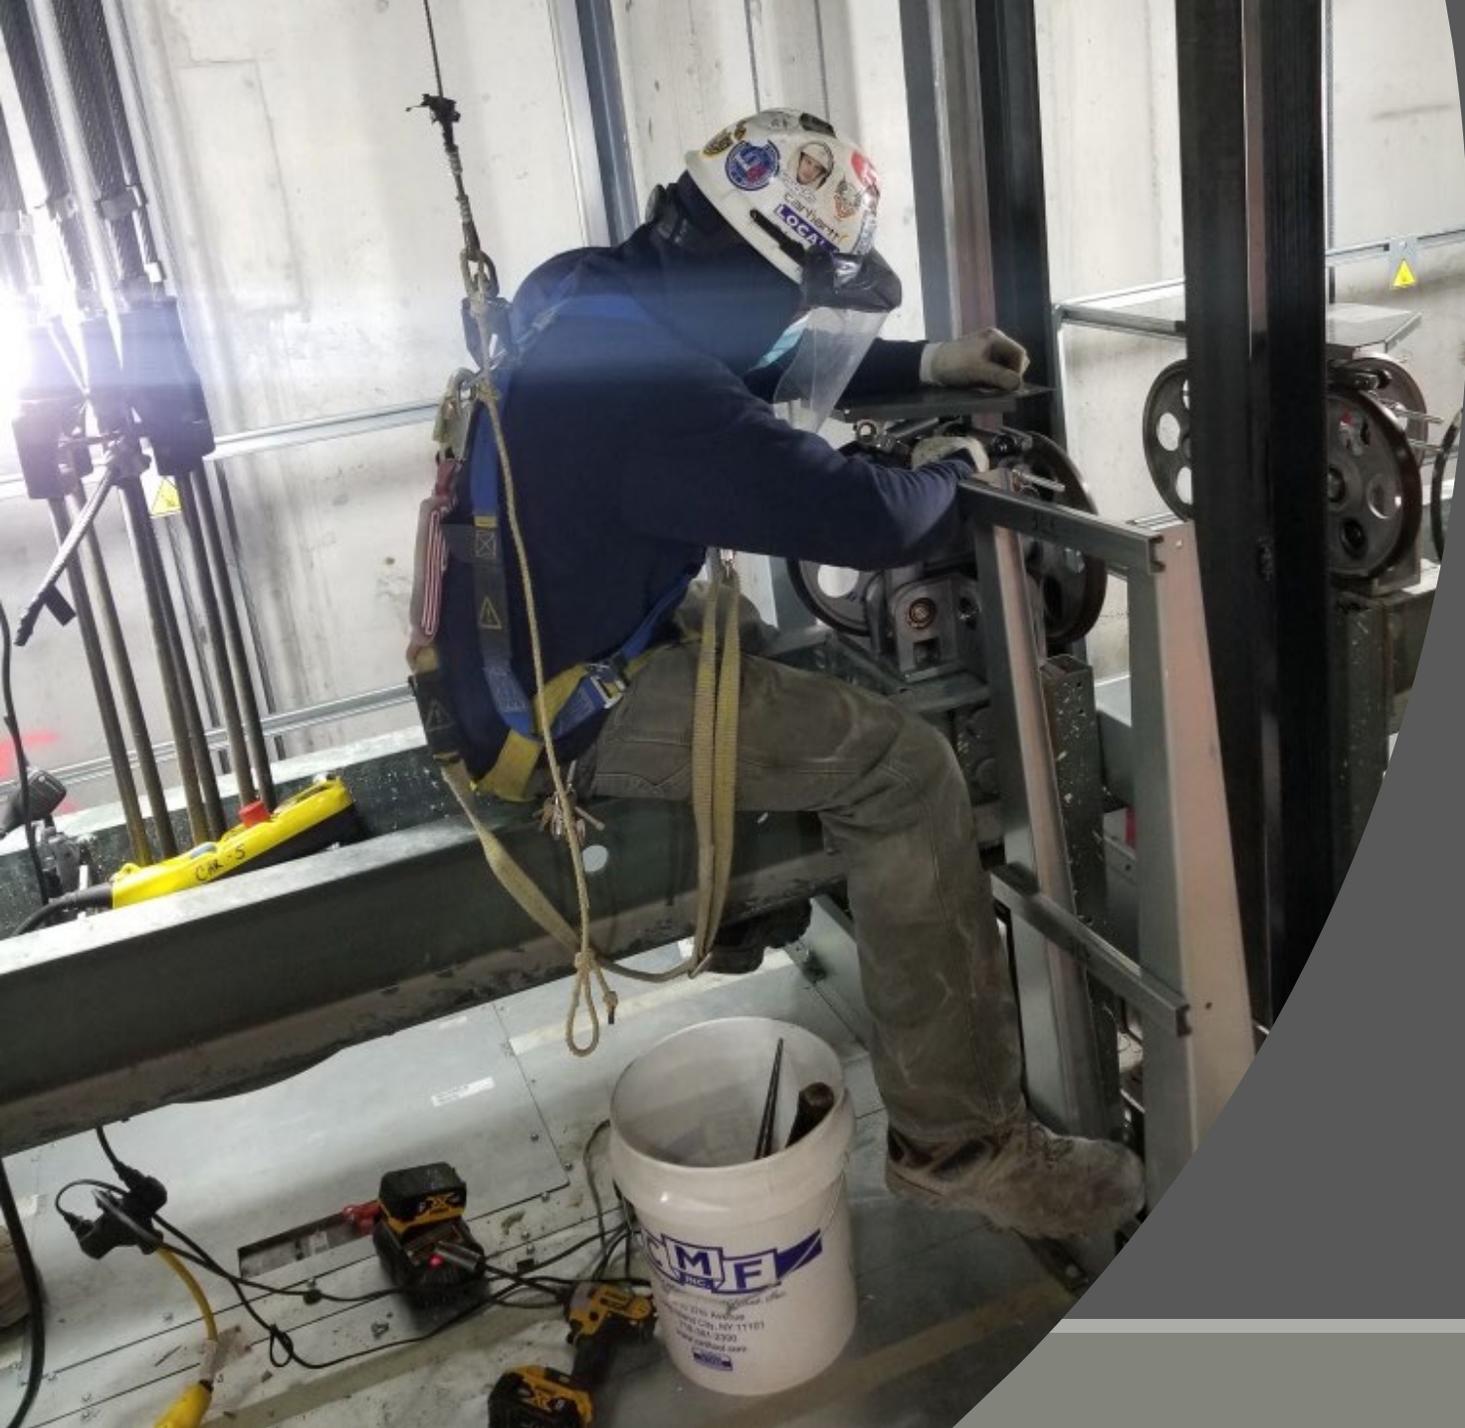
- A mechanic and apprentice were working from a go-devil/false car on a new construction job. They had just stepped off the platform on the 7<sup>th</sup> floor to grab material.
- At that instant ice debris came down the hoistway from the 22<sup>nd</sup> floor. The ice hit the crash deck that was made of 2x4's and ¾" plywood with metal mesh grating.
- The ice landed on top of the crash deck and broke thru knocking the 2x4's down the hoist way striking the go-devil.
- The crew was fortunate that that they were off the go-devil and not injured.

- Always follow the company Safety Policy.
- Always perform a JHA/JSA per company policy.
- Visually check the crash deck daily.
- Always check the surrounding areas of open hoist ways for debris, ice and or snow that if dislodged can come down the hoist way.
- Employer Responsibilities
